# MARYLAND INVENTORY OF HISTORIC BRIDGES HISTORIC BRIDGE INVENTORY MARYLAND STATE HIGHWAY ADMINISTRATION/ MARYLAND HISTORICAL TRUST

SHA Bridge No. 21041	Bridge name Sandy Hook Bridge
LOCATION: Street/Road name and num	ber [facility carried]  U.S. Route 340 over the Potomac River, CSX  Railroad, C & O Canal, and Sandy Hook Road
City/town Sandy Hook	Vicinity X
County Washington	
This bridge projects over: I	Road X Railway X Water X Land
Ownership: State X	County Municipal Other
National Register-lis	a designated historic district? Yes <u>X</u> No
Name of district Sandy I	Hook
BRIDGE TYPE: Timber Bridge: Beam Bridge	Truss -Covered Trestle Timber-And-Concrete
Stone Arch Bridge	_
Metal Truss Bridge X	_
Movable Bridge: Swing  Vertical Lift	
Metal Girder <u>X</u> Rolled Girder <u>X</u> Plate Girder	_: Rolled Girder Concrete Encased Plate Girder Concrete Encased
Metal Suspension	_
Metal Arch	
Metal Cantilever	_
Concrete Concrete Arch Other Ty	: Concrete Slab Concrete Beam Rigid Frame pe Name

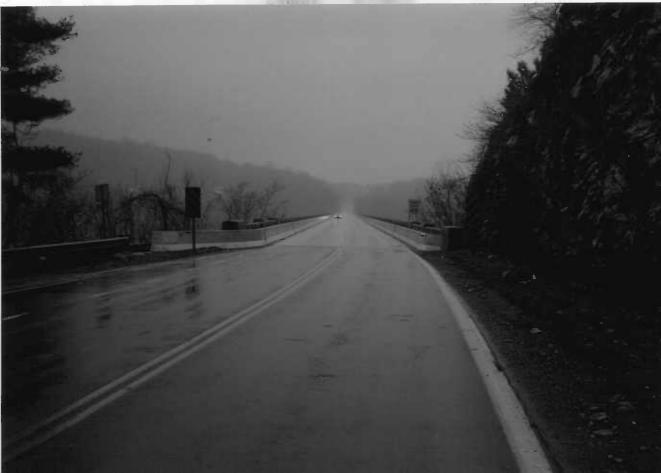
1. WA-III-163 2. 21041, Sandy Hook Bridge 3. Washington County, MD 4. Dave Dik, WMa assoc. 5. 1 Janet 1998 6. MD SHPO 7 South approach, went northern 1200 50. 8. 146

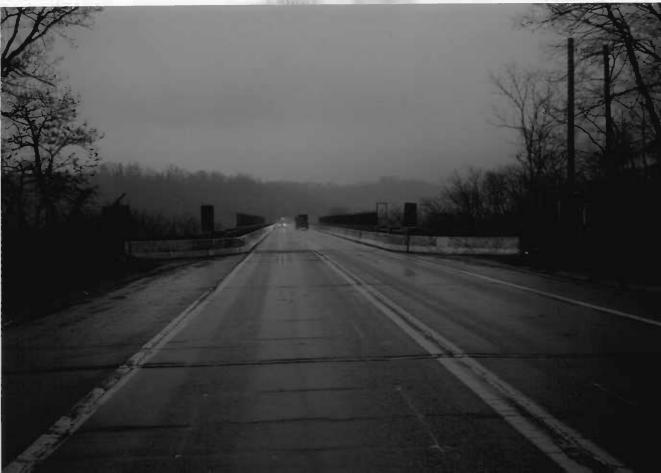
1. WA-III-168 2. 21041, Sandy Hook Bridge 3. Washington County. Maryland 4. Dave Rick, WM & Poorc. 5. March 1993 6 MO SHPO 7. North approach, view south THENN ISSON 8. 20p6

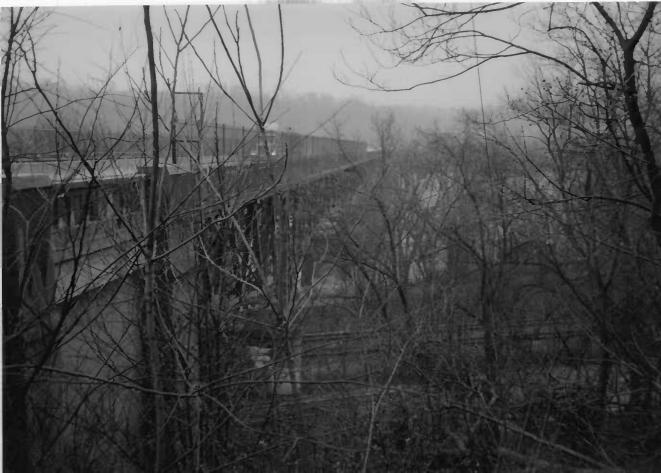
1. WA-III-168 2. 21041, Sandy Nook Bridge 3. Washington County, MD 4. Dave Dick, With a assoc. 5. March 1998 6. MD 3400

7. West elevation, view east 8. 3 of 6

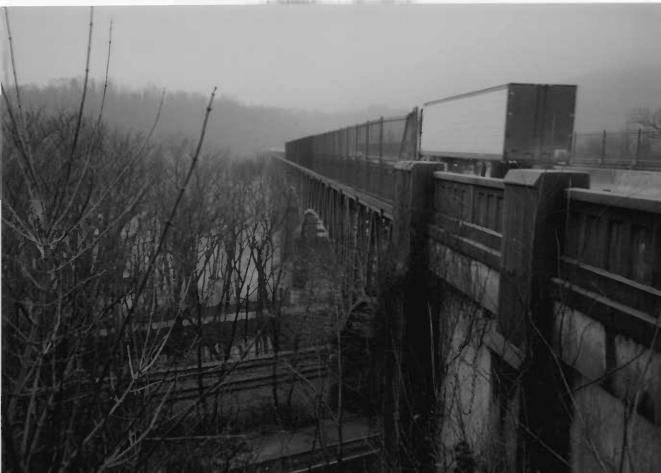
1. WA-ITF 168 2. 21041, Sandy Hook Bridge 3. Washington County, Mr. 4. Dave Dick, WM & assoc 5. March 1998 6. MD SHAD 7. East elevation, view west is the Land 8. 4of6

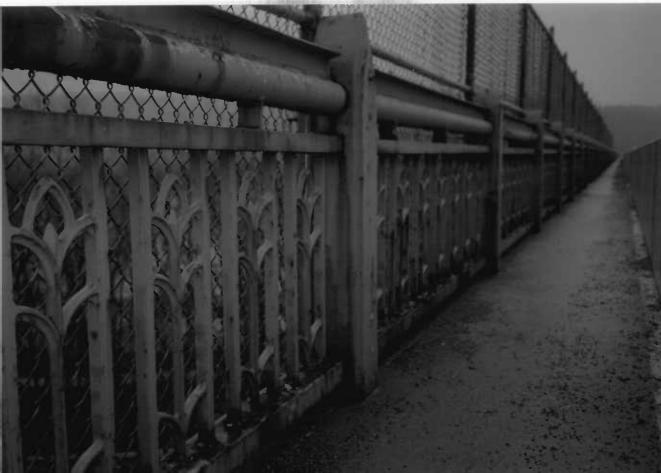
7. Detail of railing

The original construction consisted of reinforced concrete bridge deck which supported two (2) interior mountable curbs and an exterior elaborate ornamental metal railing. The sidewalk areas were built at grade with the roadway.

The original railing was modified with the addition of a structural Tee section welded to the top rail for purposes of upgrading the railing to conformity to AASHTO safety criteria. The roadway joint and backwall were replaced at each abutment. A chain link safety fence was added to the bridge at span no. 2, which spans the CSX Railroad.

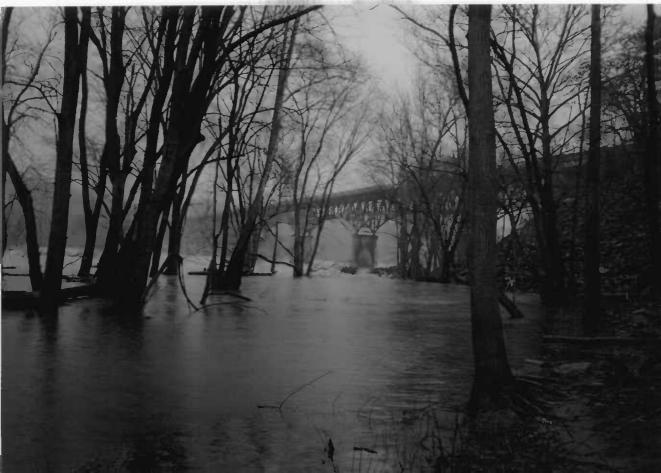
1. WA-III-168 2. 21041, Sandy Hook Bridge 3. Washington County, Mr. 4. Dave Dick, WM+ assoc. 5. March 1998 6. MD SHPO 7. West elevation, view east 8. 6966
